Field Test Report

ASTM E 2128 Water Leakage Investigation

Eudora Welty Library
300 North State Street
Jackson, MS 39201

13 Sept 2015

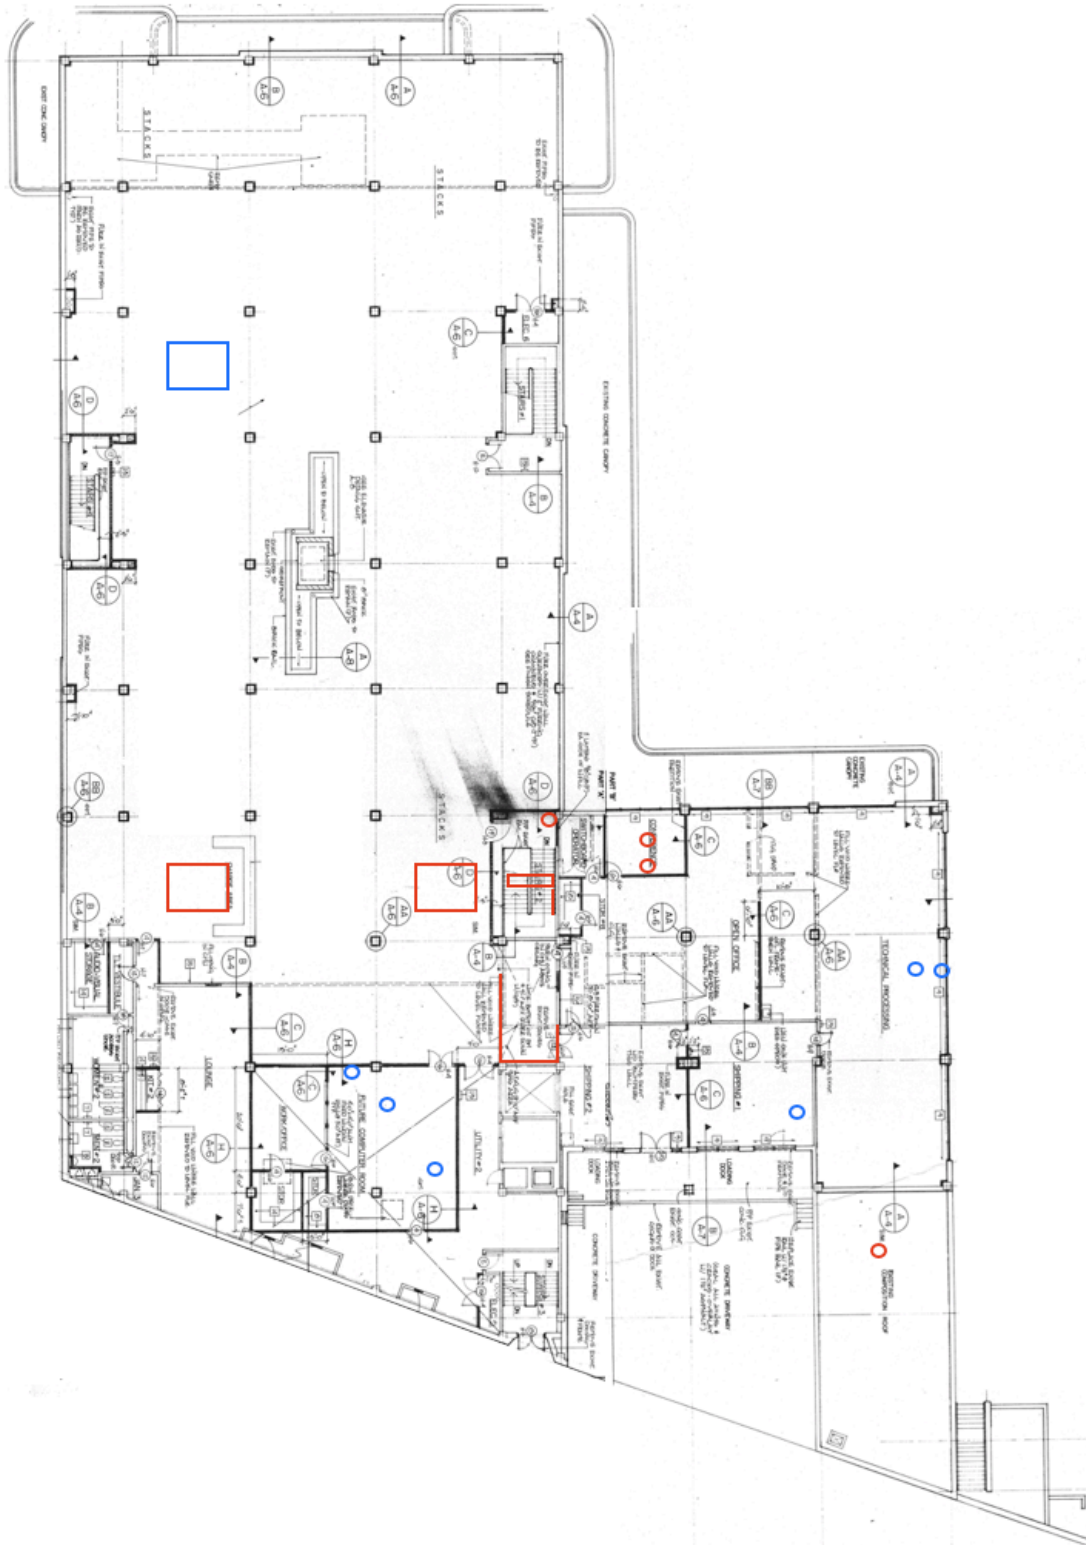
2.0 Leakage Areas Identified

This second floor plan view drawing shows the areas identified as having water leakage from the concrete ceiling. The red shapes are areas where the water leakage was identified to BLI&T during the preliminary inspection conducted on 19 Jun 2015 and the blue areas are where water leakage was found and/or identified after arrival to conduct these water leakage tests.

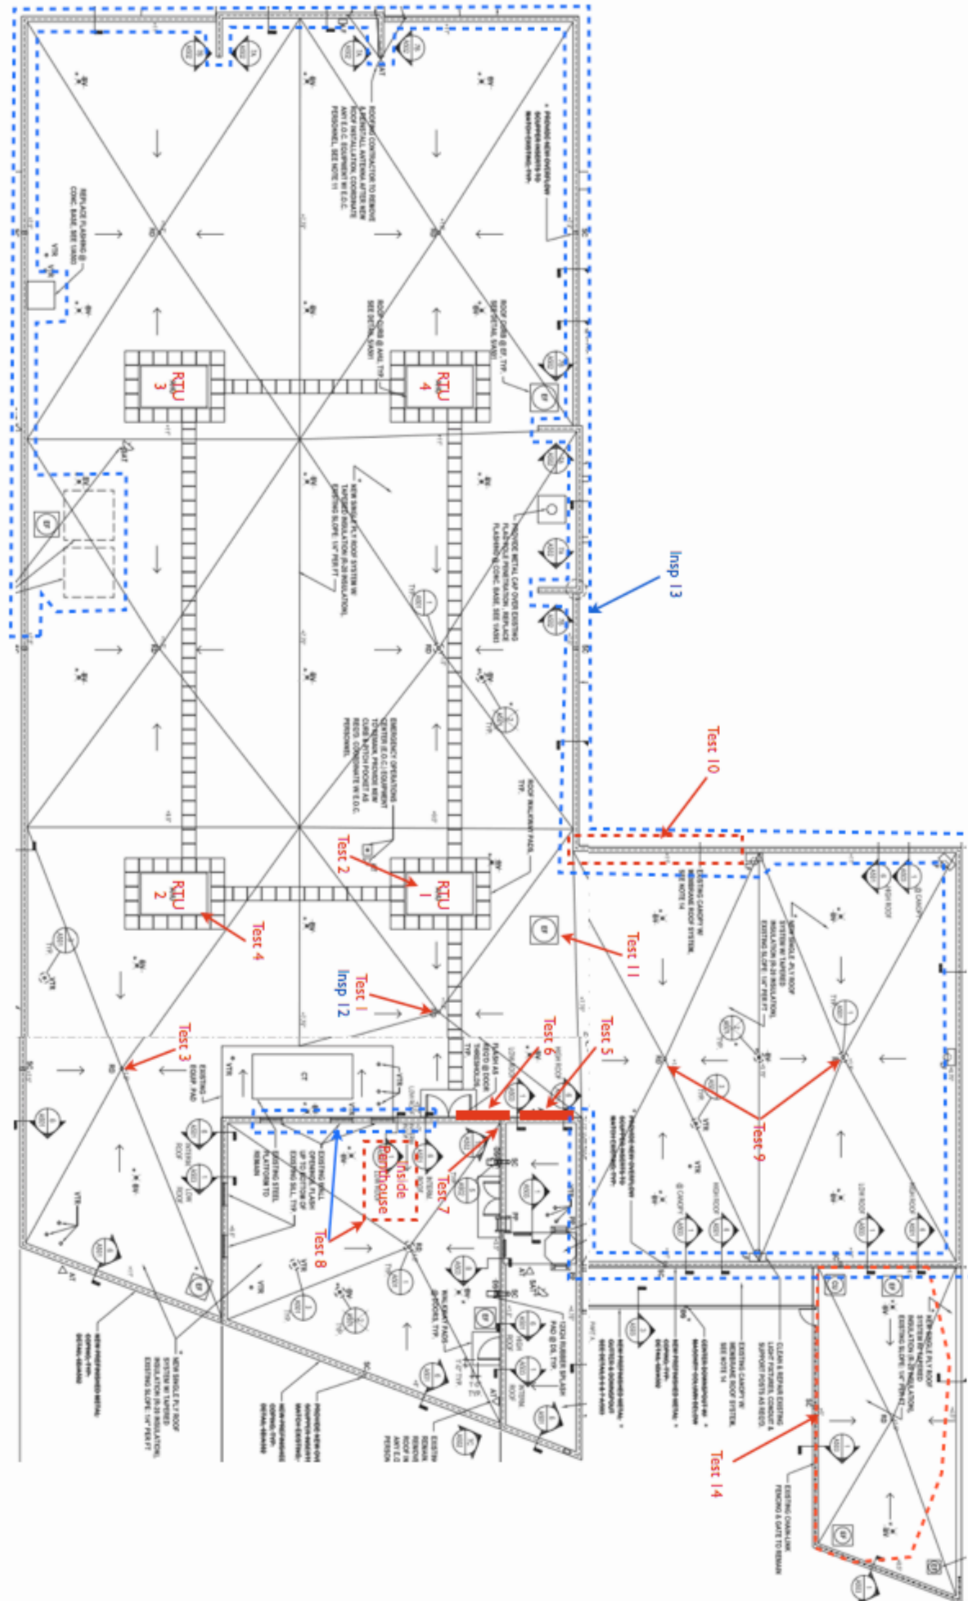
3.0 Test and Inspection Areas Identified

The following roof plan view drawing shows the location and number of the areas tested and inspected during this water leakage investigation.
